# SHOWCASE 03 : SHANGHAI XIAOJIPU RIVER

## Shanghai Xiaojipu River Remediation

## Shanghai Xiaojipu River Remediation, iQPR Technology and iQPR Water applied on June 25, 2010

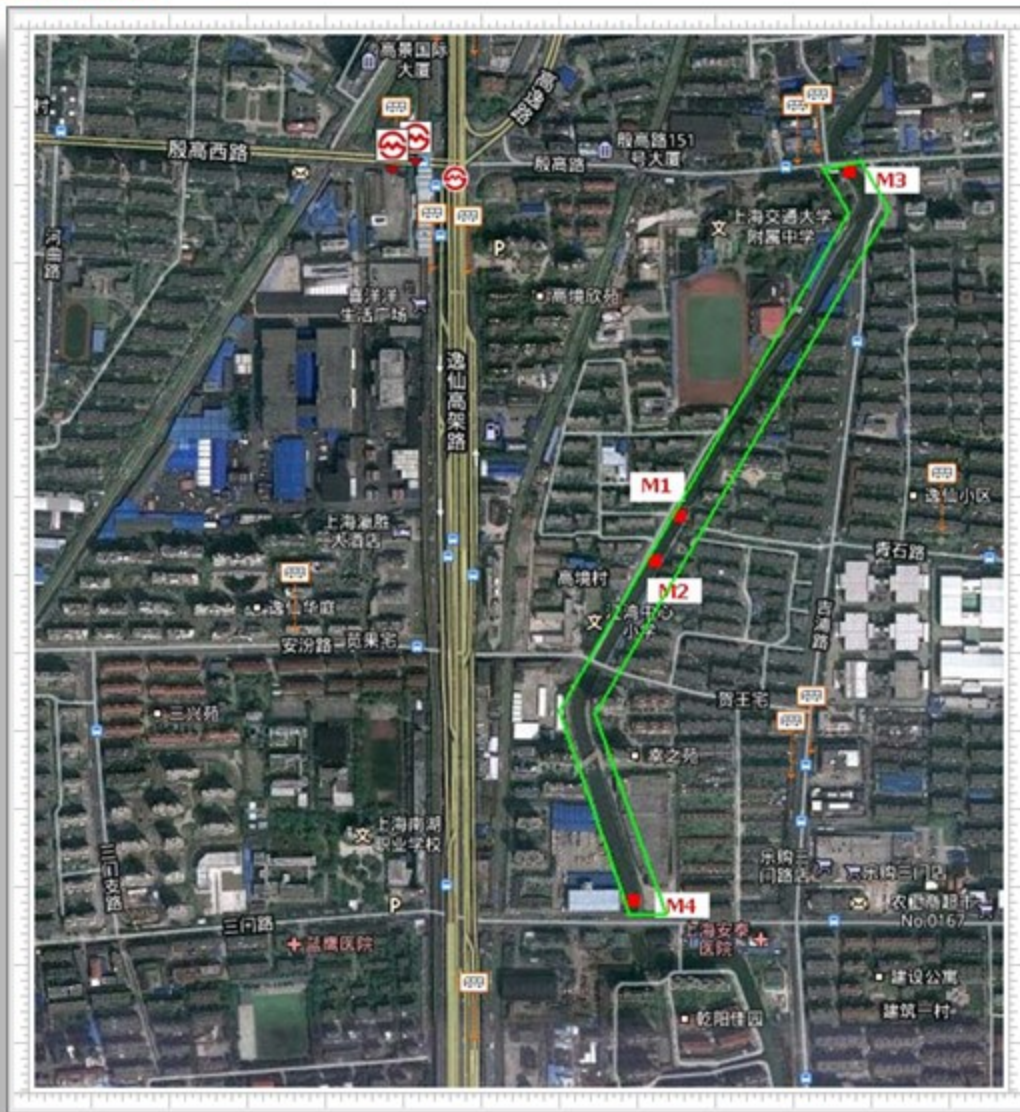
## Shanghai Xiaojipu River Remediation Zone Plan

- M1 ( 整治区 )
- M2 ( 整治区 )
- M3 ( 股高路 )
- M4 ( 三门路 )

- 治理範圍
- Treatment Boundary
- 採樣/監測點
- Sampling monitoring Location

Xiaojipu river is approximately 5.152 kilometers in total length (within Baoshan 4.1 km), across the two districts of Baoshan and Yangpu. The river is not only dirty, heavy polluted, and foul smelling, it is also upsetting the nearby residents. Efforts to cleanup the waterway over the year have been attempted before but failed to solve the problem with the conventional methods. The reasons of failure to solving the problem are first Xiaojipu district is a highly populated coastal city and its urban infrastructure is very weak, most of the district is still using combined rainwater and sewage drainage, therefore rainwater and sewage are discharged directly into the river with the storm water pumping station, and is main reason that is causing the river water quality instability. Second reason is Xiaojipu river is a decapitation (beheaded) River, the river water flowrate is obviously insufficient, and the upstream does not have any incoming clean water.

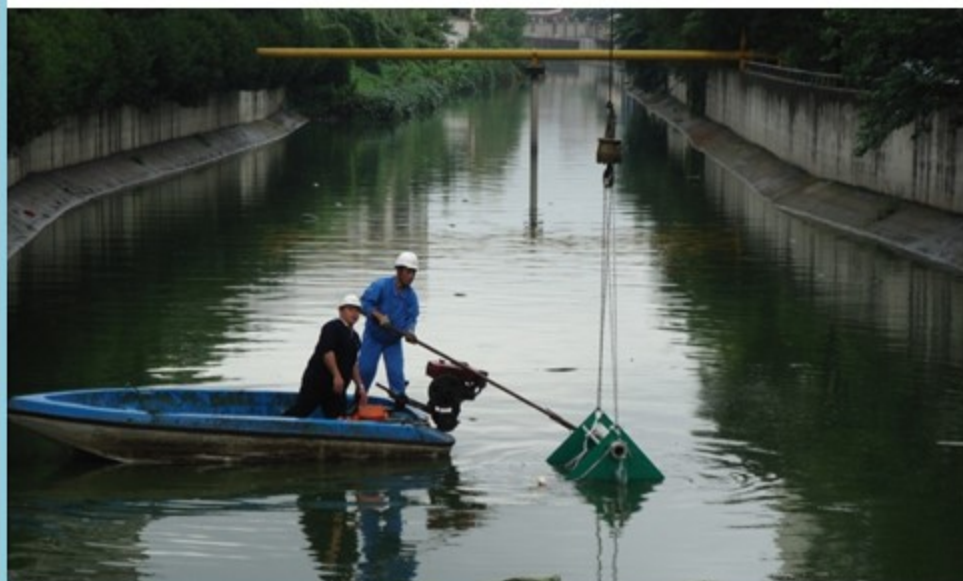
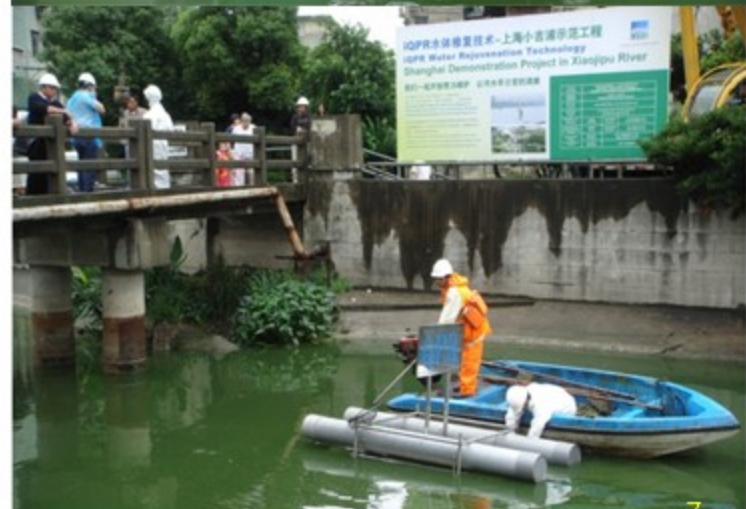
Ongoing Installation of iQPR Equipments by the Staffs

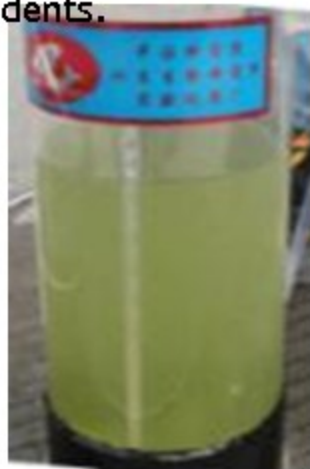
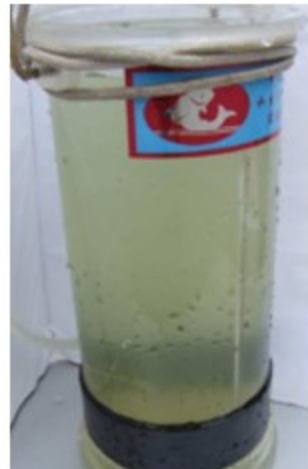
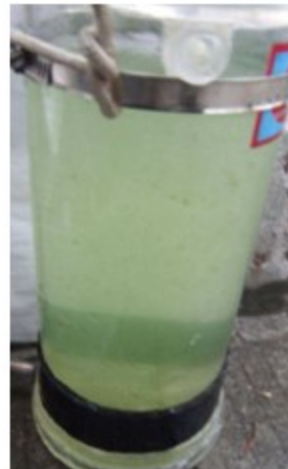
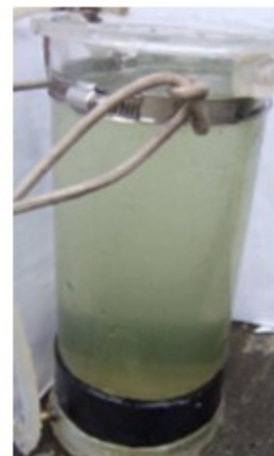
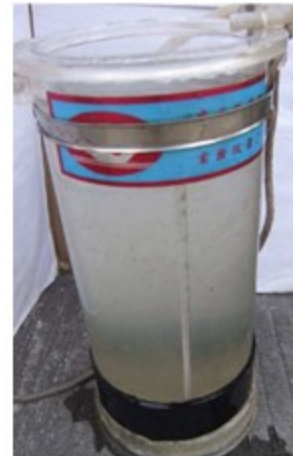
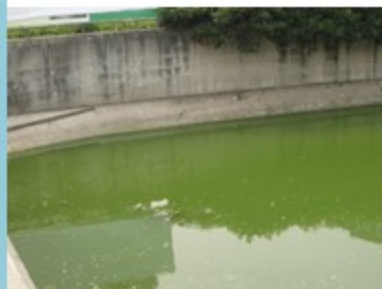
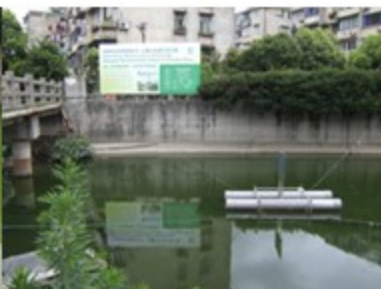
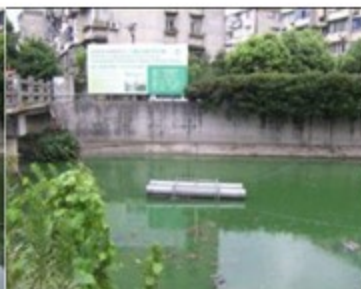
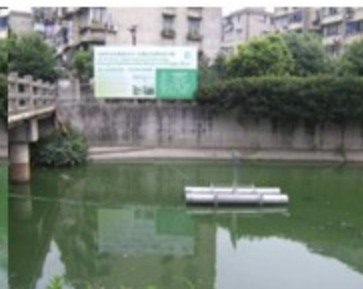
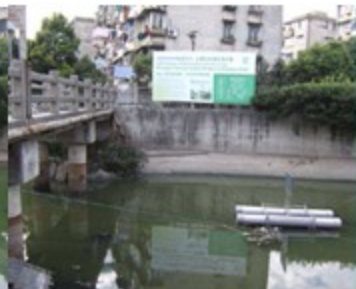
Xiaojiipu (Yingao Road to Sanmen Road Section) river remediation demonstration project in cooperation with the Baoshan Bureau Water Authority was successfully completed on December 25, 2010. Treatment result has achieved the desired goals, and has been recognized by the Water Authority and the surrounding residents.

23 June 2010 (Before)

24 June 2010 (After)

25 August 2010 (After)

28 Sept 2010 (After)

29 Oct 2010 (After)

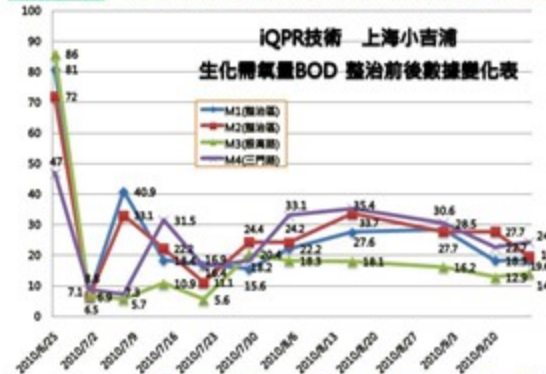
日期	2010/06/25 整治前				2010/07/01 浮台車淨化				2010/07/07 浮台車淨化 (大風淨化)				2010/07/14				2010/07/21				2010/07/29			
檢測點	M1	M2	M3	M4	M1	M2	M3	M4	M1	M2	M3	M4	M1	M2	M3	M4	M1	M2	M3	M4	M1	M2	M3	M4
整治天數	0				7				13				20				27				35			
五日生化需氧量BOD	81.0	72.0	86.0	47.0	7.1	6.5	6.9	8.8	40.9	33.1	5.7	7.3	18.4	22.2	10.9	31.5	16.9	11.1	5.6	16.4	15.6	24.4	20.4	18.2

日期	2010/08/05				2010/08/16 06:15集雨				2010/09/01				2010/09/10				2010/09/16				整體下降率			
檢測點	M1	M2	M3	M4	M1	M2	M3	M4	M1	M2	M3	M4	M1	M2	M3	M4	M1	M2	M3	M4	M1	M2	M3	M4
整治天數	42				53				69				78				84				77.3%			
五日生化需氧量BOD	22.2	24.2	18.3	33.1	26.7	33.7	18.1	35.4	28.5	27.7	16.2	30.6	18.3	27.7	12.9	22.7	18.4	19.6	14.1	24.3	77.3%	72.8%	83.6%	48.3%

全區已無臭味

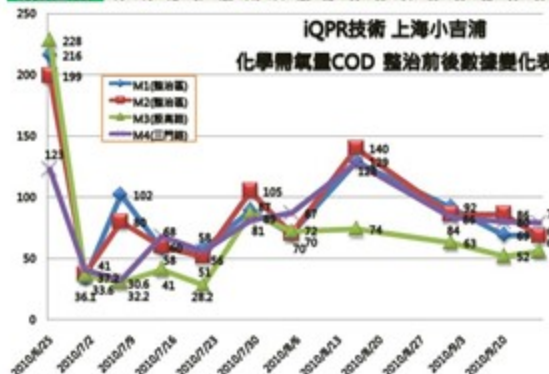
日期	2010/06/25 整治前				2010/07/01 浮台車淨化				2010/07/07 浮台車淨化 (大風淨化)				2010/07/14				2010/07/21				2010/07/29			
檢測點	M1	M2	M3	M4	M1	M2	M3	M4	M1	M2	M3	M4	M1	M2	M3	M4	M1	M2	M3	M4	M1	M2	M3	M4
整治天數	0				7				13				20				27				35			
化學需氧量COD	216	199	228	123	33.8	37.2	36.1	41	102	80	30.8	32.2	96	60	41	68	66	51	28.2	56	105	87	81

日期	2010/08/05				2010/08/16 06:15集雨				2010/09/01				2010/09/10				2010/09/16				整體下降率			
檢測點	M1	M2	M3	M4	M1	M2	M3	M4	M1	M2	M3	M4	M1	M2	M3	M4	M1	M2	M3	M4	M1	M2	M3	M4
整治天數	42				53				69				78				84				68.1%			
化學需氧量COD	70	70	72	87	129	140	74	128	92	63	84	89	62	90	69	66	66	79	68.1%	65.8%	75.4%	35.9%

全區已無臭味

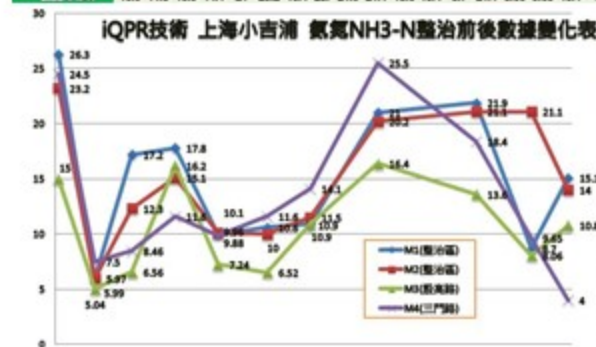
日期	2010/06/25 整治前				2010/07/01 浮台車淨化				2010/07/07 浮台車淨化 (大風淨化)				2010/07/14				2010/07/21				2010/07/29			
檢測點	M1	M2	M3	M4	M1	M2	M3	M4	M1	M2	M3	M4	M1	M2	M3	M4	M1	M2	M3	M4	M1	M2	M3	M4
整治天數	0				7				13				20				27				35			
氨氮NH3-N	26.3	23.2	15	24.5	5.97	5.99	5.04	7.5	17.2	12.3	8.98	8.46	17.8	15.1	16.2	11.6	9.96	10.1	7.24	9.88	10.0	9	6.82	11.6

日期	2010/08/05				2010/08/16 06:15集雨				2010/09/01				2010/09/10				2010/09/16				整體下降率			
檢測點	M1	M2	M3	M4	M1	M2	M3	M4	M1	M2	M3	M4	M1	M2	M3	M4	M1	M2	M3	M4	M1	M2	M3	M4
整治天數	42				53				69				78				84				42.6%			
氨氮NH3-N	10.9	11.5	10.9	14.1	21	20.2	18.4	25	21.9	21.1	13.6	18.4	8.7	21.1	8.06	9.65	15.1	14	10.8	4	42.6%	36.7%	28%	83.6%
