# SHOWCASE 04 :

## WEI FENG CANAL, TAIPEI, TAIWAN

# iQPR TECHNOLOGY™ WELL TESTED IN TAIWAN

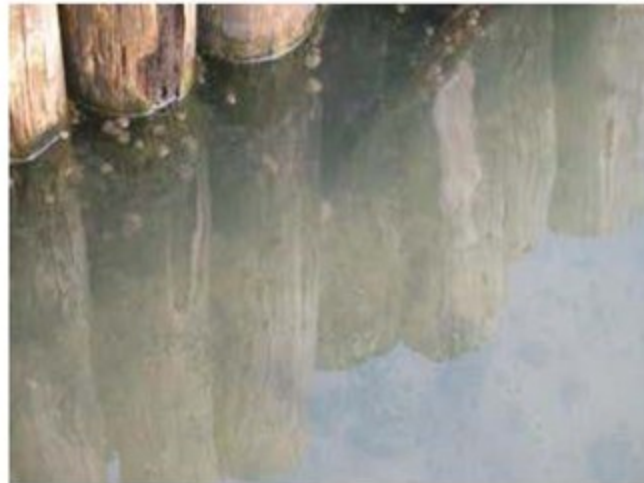
Sustainable good water quality - clarity and aqua life is thriving in the water - 878 days after treatment.  
Note: The above picture was taken on 20 March 2010.

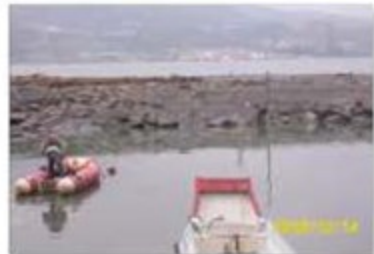
Before Treatment

**Above:** The growth of moss is an excellent indicator of improved water quality and ecology. Revival of fishing activities can be seen at the river.

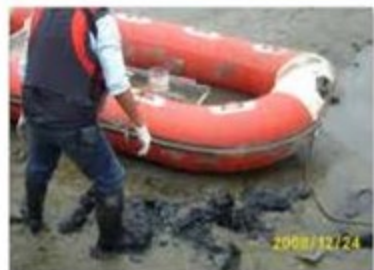
Before Treatment

**Below:** Mud and slush clear over time.

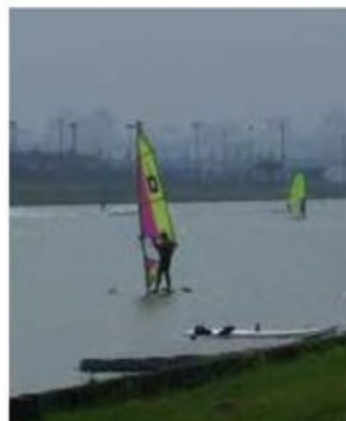
**Right:** There are 14 sewers discharging pollutants along this river. iQPR Technology is able to rehabilitate the water and soil effectively even though pollutants are continuously discharged into the river.
